Bangladesh, Floating Dual-Fuel Power Barge

Root Cause Investigation of Multiple Failures of a Large Dual-Fuel Engine

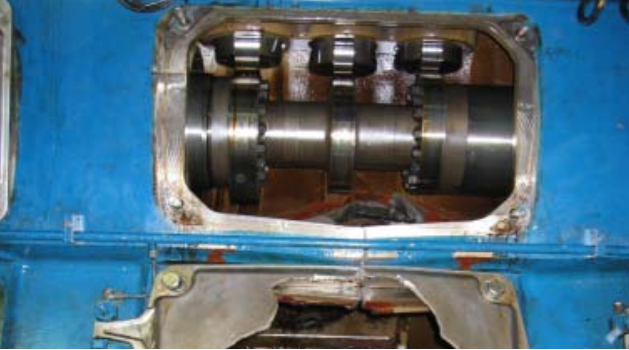
MPR received a request from the plant owner of the world's largest floating dual-fuel power barge in Bangladesh to conduct an independent root cause investigation into successive failures of one engine. The owner was concerned that the engine, which had been rebuilt one week earlier, had failed again. The 18-cylinder, 20,000 bhp engine is the prime mover for one of eight 15-MWe units, and electrical power already in short supply in the country had become even more scarce. This failure was a more serious break down involving two pistons and connecting rods being ejected from the dual-fuel engine's crankcase. One connecting rod was bent more than 45 degrees and the second connecting rod, along with several pistons and cylinder liners, was fractured.

MPR completed the detailed root cause investigation that determined the engine did not fail due to improper operator action or faulty maintenance. The common link found between the two failures was a cracked exhaust valve seat in one cylinder head that allowed cooling water to leak into the cylinder while the engine was shut down. When restarted, some of the water in one cylinder was pumped into the adjoining cylinder via the common exhaust manifold. A number of hydraulic lock impacts weakened one connecting rod to the point of fracture. As a result of MPR findings during the root cause investigation, MPR was asked to serve the role of technical expert for the owner's engineer at mediation meetings in London with the power barge's insurance company and the diesel engine manufacturer.
